## RESEARCH OF MORPHOLOGICAL PROCESSES INTO THE MOLDOVA RIVERBED USING PERIODIC TOPOGRAPHIC MEASUREMENTS

### Abstract

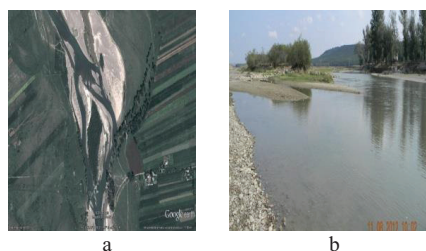
Figure 2. Pictures of the Moldova River area:  
 a – Google earth view (2012);  
 b – Downstream view of the studied area

Moldova River in the studied area shows a strong degree of instability (where the adduction pipes undercross the river Figure 2). Following transit floods were was recorded constantly morphological changes in the spatial configuration of the river. The most significant changes were:

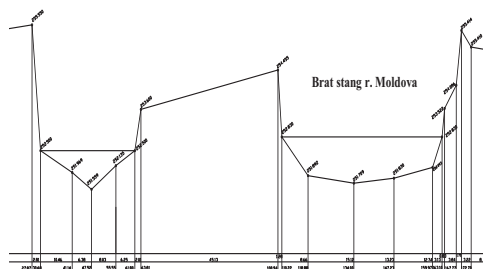
Figure 3. Cross section profile in adduction ducts undercrossing area (year 2006)

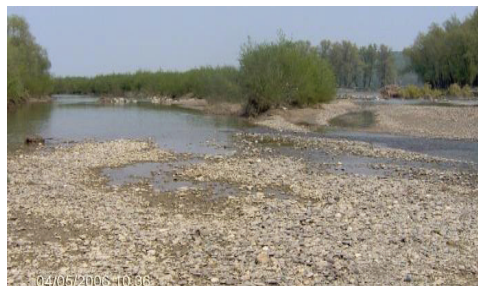
Figure 4. Downstream overview of the studied river section (left and right branches stands island and ballast foundation of the riverbed, year 2006)

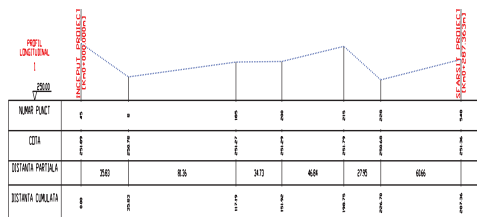
Longitudinal profile through its two branches of the river was changed by lowering the thalweg level in the last 15 years.

- Longitudinal profile highlights the significant slope variation in the length of the studied riverbed. In the area where the adduction ducts is produce super elevation of the bottom of the bed due to the presence of the shoulder made by the pipe. Achieving further thresholds made of rough stone on pipeline routes modify the longitudinal profile parameters;

Figure 5. Longitudinal profile through Moldova riverbed in the research area

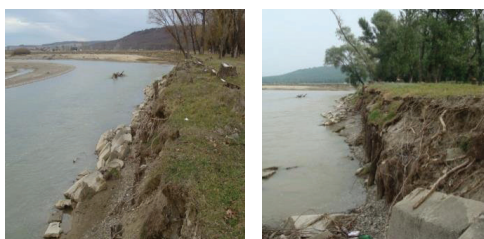
Figure 6. Degradation of left shore protection works of Moldova River after floods in 2010

Alluvial processes have developed to the right side of the riverbed and especially around the island. Erosion processes were developed left bank. Left bank erosion intensified in 2005 and was manifested by washing alluvium, degradation and total destruction of bank protection etc. Excavating ballast upstream undercrossing influenced the intensification of hydrodynamic erosion.

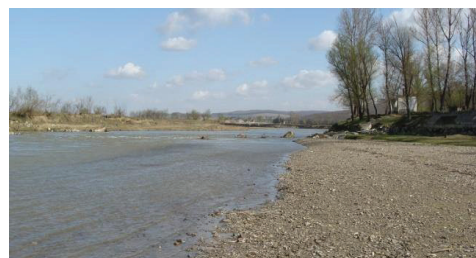
▪ In the river shows a relative stability in the plan and is less affected by phenomena of collapse or erosion (Figure 7).

Figure 7. Downstream overview downstream of the left arm of river in the study area (year 2015)
