## RESEARCH OF MORPHOLOGICAL PROCESSES INTO THE MOLDOVA RIVERBED USING PERIODIC TOPOGRAPHIC MEASUREMENTS

### Abstract

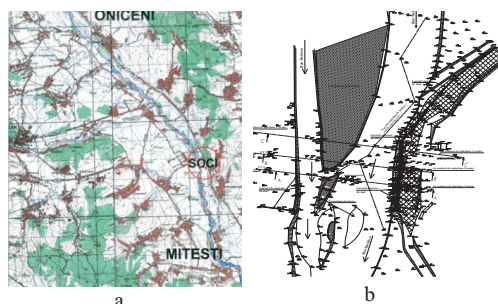
Figure 1. Map of studied area:  
 a – research area on the Moldova River;  
 b – Land survey on investigated river section in 2005
