SEISMIC PROTECTION OF INDIVIDUAL BUILDINGS LOCATED IN RURAL AREAS

Abstract

Key words: masonry, timber, bracing, belt beams.

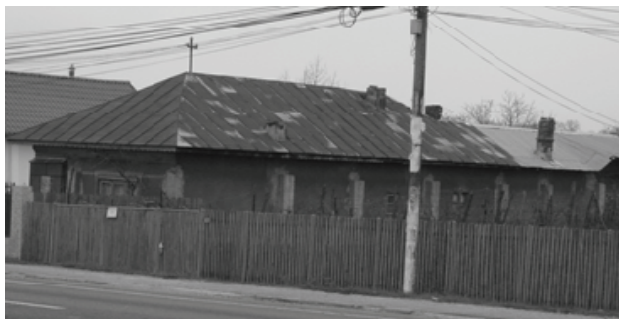
Figure 2. Strengthening of the external walls with some buttress to a traditional dwelling

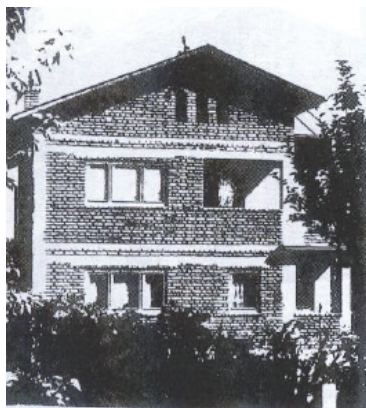
Figure 3. City type rural two storied brick masonry dwelling with embedded RC columns and RC slabs (the collar beam as a frame beam)

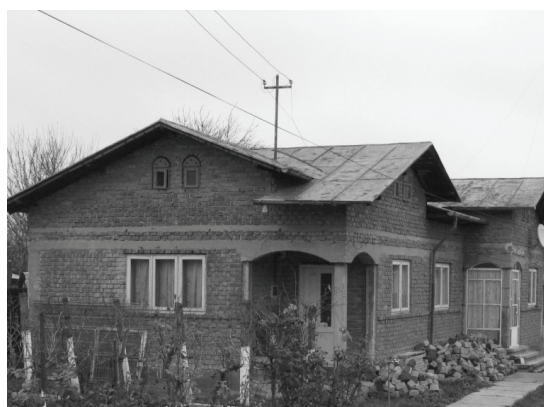
Figure 6. City type rural two storied brick masonry dwelling with embedded RC columns and RC slabs (the collar beam as a frame beam)

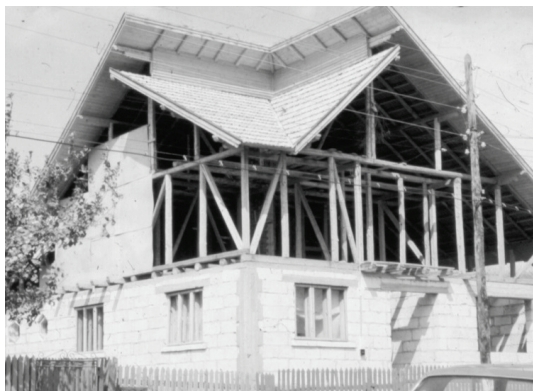
Figure 7. A traditional dwelling with roof band and RC lintels, pillars at corners, a light roof, in 2-4 slopes having a structure well tight with the masonry

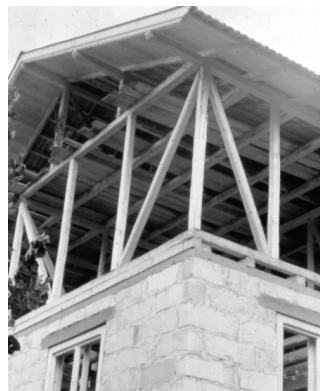
Figure 8. A traditional dwelling with roof band and rc lintels, without pillars at corners, a light roof, in 2-4 slopes having a structure well tight with the masonry

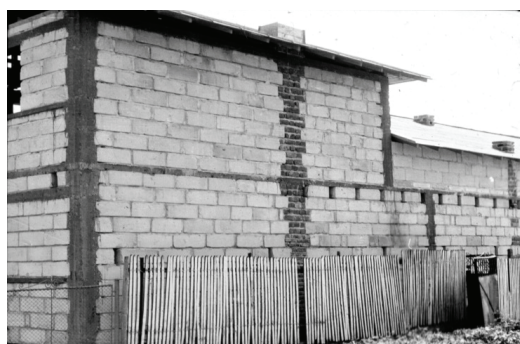
Figure 9. A traditional dwelling with RC floor and without RC belts

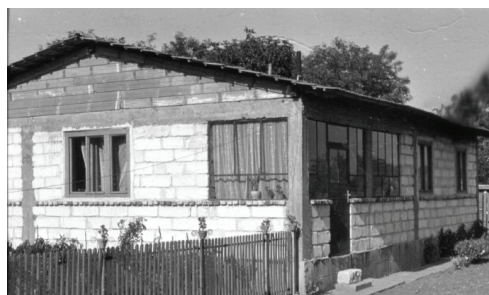
Figure 10. A traditional dwelling with RC floor slabs (lintels are embedded in RC floor slab)

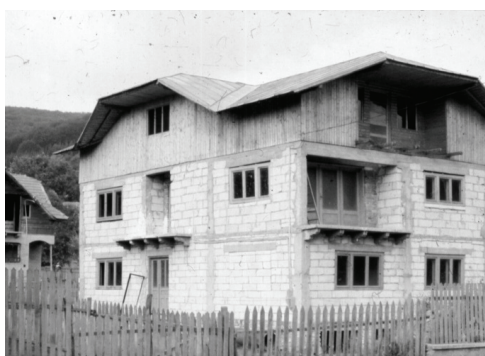
Figure 11. City type rural three storied brick masonry dwelling RC skeleton mixed with timber beams

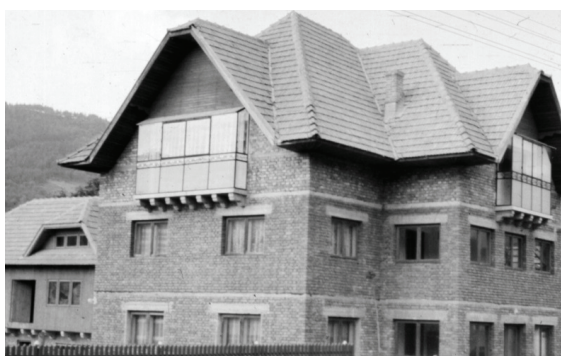
Figure 12. City type rural three storied brick masonry dwelling with RC floor slabs and without RC belts
