## PROCESS AUDIT AT A GRINDING PLANT (CEMENT MILL) AT A CEMENT FACTORY - A CASE STUDY IN ROMANIA

The process audit is an analysis for the operation of an equipment, to establish its performance and to make proposals for measures to increase production, decrease consumption and improve product quality. The objective of the process audit is to establish the actual state of operation for the cement grinding plant (the degree of loading with grinding bodies, the air speed in the mill, the granulation of the material at the entrance and the exit, the wear of the shields, energy consumption) and is the basis for proposing measures for optimization. The audit from a grinding plant is carried out in the following situations: upon commissioning (to record the initial condition of the equipment) after modernization/modifications of the equipment in the composition of the grinding plant whenever there are deviations. The aper presents some determinations made at a cement mill from a Romanian cement factory, the sampling method to carry out analyses and recommendations for improving production.

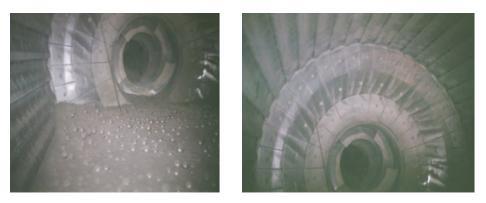
Figure 1. Aspects at the entrance to the mill - material level and cascade armours for chamber I

#### Remarks: armours in good condition.

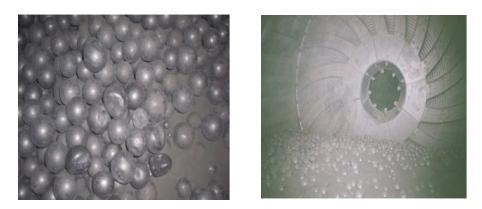
Figure 2. Broken balls, deformed balls (detail), respectively the partition wall, the ventilation ring, the material level and the cascade shields - chamber I

*Observation:* Material below the ball level, missing material on the left side of the mill and broken and deformed grinding bodies and the presence of grinding bodies from chamber II.

- increasing the load of the mill with material, respectively increasing the degree of recirculation;
- increasing the degree of filling of the mill with grinding bodies to the maximum level allowed in both chambers, in order to increase productivity;
- increasing air speed through the mill by increasing aeration;
- increasing the weight of the average ball in room I;
- periodic inspection of the interior of the mill and intervention at the slots, diaphragm, wall exit mill, armour, etc.
- periodic cleaning of the bulkhead slots and the wall at the outlet of the stuffed ball mill, as well as the exhaust screen around the spray nozzle.

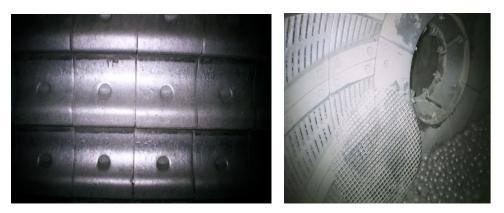
Figure 3. Cascade shields (detail) and slots in the partition wall with ventilation ring (detail) - chamber I

**Observation**: Field armour in good condition. The internal equipment of the mill - Chamber II

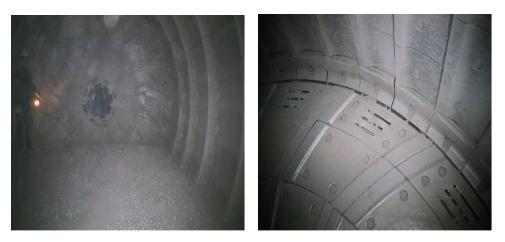
Figure 4. Partition wall, self-sorting shields, the material level and the slots in partition wall (detail) - chamber II

*Remarks:* the shields in the partition wall and those at the mill outlet are in good condition, but the material is below the level of the balls. In addition, there are balls wedged between armours and slots partially blocked with balls.

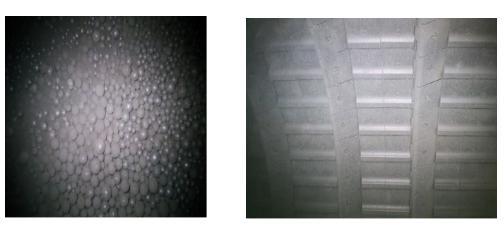
Figure 5. Balls distribution and self-sorting shields (detail) - chamber II

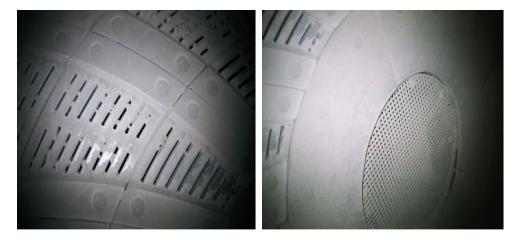
Figure 6. The slots in the mill outlet wall (detail) and mill outlet grate (detail) - chamber II

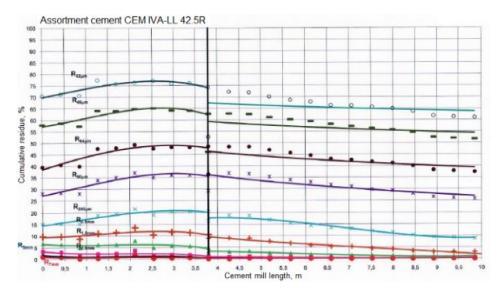
To perform the grinding diagram, the cement mill was instantly switched off. Material samples were taken from 0.5 m in 0.5 m, in three directions along the mill, by CEPROCIM personnel. On the material samples, the residences were determined on the 5 mm, 2.5 mm, 1 mm, 200  $\mu$ m, 90  $\mu$ m sides of the eye, 64  $\mu$ m and 32  $\mu$ m and specific Blaine surfaces (room II) in the CEPROCIM laboratory and then the grinding diagram was drawn. The results are shown in Figures 7 and 8.

Figure 7. Cement mill. Milling diagram. Three-way sample average

The analysis of the grinding diagram highlights the following aspects:

Chamber I:

✓ well prepared material in room I - R<sub>2.5mm</sub> = 1.99% at the partition wall, in conditions of a mill insufficiently loaded with material. Chamber II:

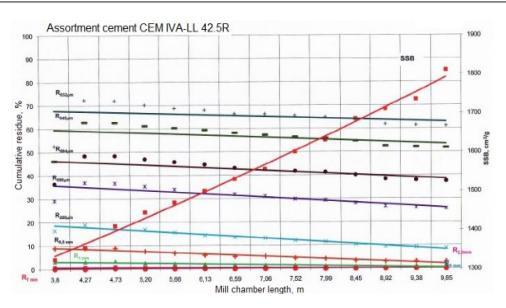
Figure 8. Cement mill. Residues evolution and Blaine specific surface area (SSB) in chamber II

Chamber II:

- ✓ active grinding along the entire length of the chamber;
- ✓ R<sub>90µm</sub> when leaving the mill (separator supply) cca 8%.

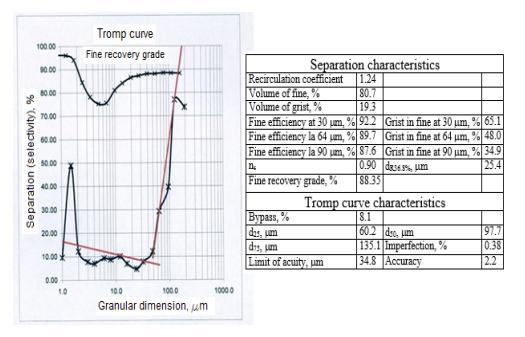
The efficiency parameters of the separator were also calculated based on the laser granulometric distributions; the Tromp selectivity curve being drawn (Figure 9).

Figure 9. Tromp curve. Characteristics of separation at the cement mill

It was found that the recirculation coefficient, calculated from the results of the laser granulometric analysis, was within the recommended range (2-2.5), with positive implications on production, but the degree of recovery of the fin (f) was relatively low (approximately 42%). However, the degree of wheat recovery (g) was very good (99.5%). Also now, the efficiency parameter values are characteristic of the third generation of separators.

It can be said that the efficiency parameters of the separator are favourable, located between those specific to the second and third generations of separators, under the conditions of low recirculation coefficients.

- periodic inspection of the interior of the separator;
- the value of the by-pass is within the range specified by the literature for the manufacture of this type of cement (5-15%);
- the slope of the RRS right indicates a narrower distribution of particle sizes in cement, which may be beneficial for the final strength of the cement. For this type of manufactured cement, the literature mentions the range of 0.85-1.15 for the slope of the RRS right.
